**USACE contact for EJ****Terry Brown** to: Kenneth Champagne

Subject: cell 1

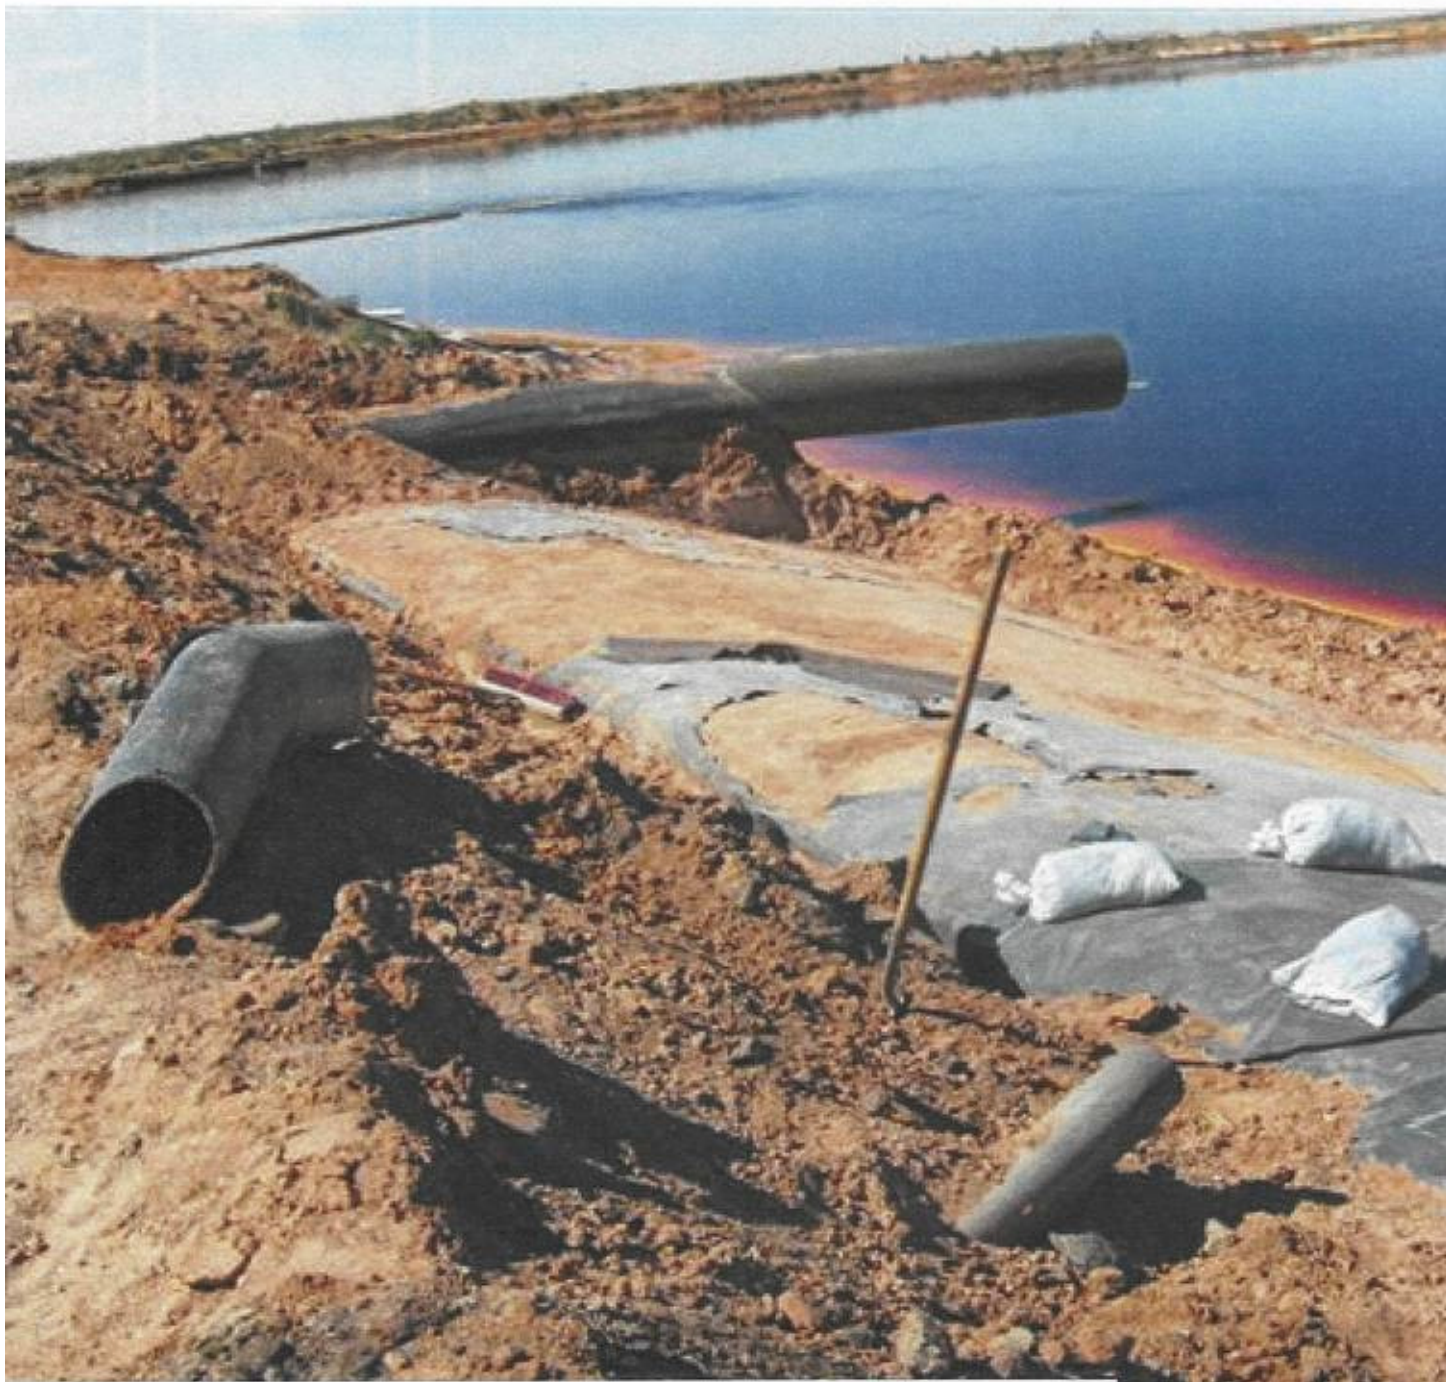
Sam Vance asked recently if we thought the existing chloroform plume under the mill could be the source of the vinyl chloride found in some monitoring wells, but our hypothesis is that it came from holes like this one being dissolved in the PVC liners. Our liner engineering expert agrees.

The reports EFR filed show that the liner material they did expose was either extremely degraded or missing entirely around the extent of the cell (additional confirmation that the "leak detection" system under cell 1 is junk) so I don't see how the remainder would be any different and we need to see if DRC gave EFR a pass and approved this "repair" or if they are doing the right thing

Example of liner damage adjacent (smaller bare spot) to section of liner removed (larger bare spot) for replacement. Area is on east slope of Cell 1, just north of main discharge pipe from Mill/SX area.

So, I guess we need to do another GRAMA request on this cell 1 issue. This cell 1 repair report we received from phil requires DRC (executive secretary) review and approval, this wasn't included. We need the DRC response on this repair/report because EFR was only required to drop the solution level in cell 1 to 5,613 feet amsl. The bottom elevation of cell 1 is somewhere around 5,980 feet amsl, as you can see in the photo below most of the solution remained in the cell so most of the liner was not examined/repaired.
